ETC TEST REPORT

Ind. Ser. No. : 08-08-EAT-025-E00
 Applicant : Dinkle International CO., LTD.
 Address : No.3, Min An Rd., Hsin Chuang, 242
 Taipei Hsien, Taiwan.
 Commodity : Connector
 Model : MSTB25 、 2EHDR-05P
 Quantity : 3 pcs/model ; Total : 6 pcs
 Date of Receipt : Aug. 08, 2008
 Date of Testing : Aug. 12, 2008~ Aug. 14, 2008
 Ambient Environment : Temp. 25°C, R.H. 55%
 Testing Item :

1. Thermal shock test
2. Low temperature storage test

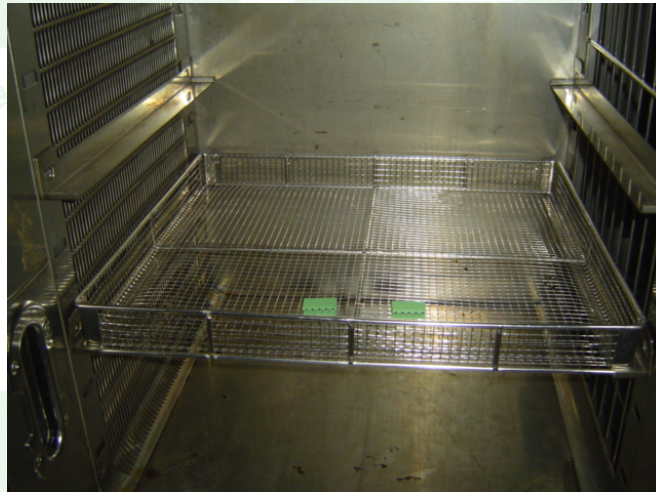
Fig. 1 Thermal shock test

1. Thermal shock test

Test sample : MSTB25#1 、 2EHDR-05P#1

Test setup : Refer to Fig.1

Sample No.	Visual inspection
MSTB25#1	No damage.
2EHDR-05P#1	No damage.

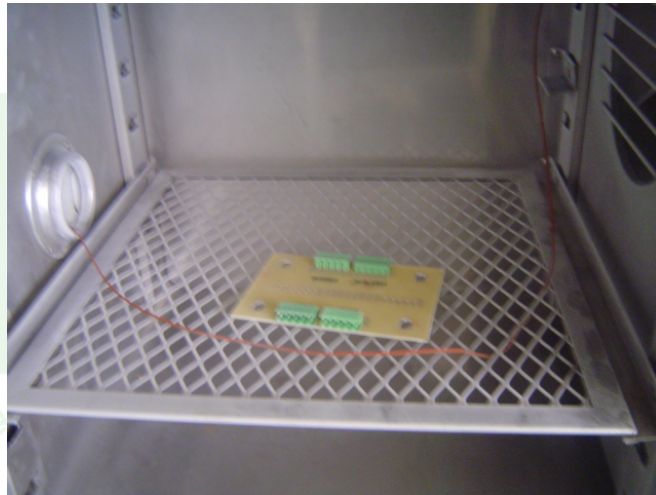
Fig. 2 Low temperature storage test

2. Low temperature storage test

Temperature : -40°C

Duration : 4 hour

Test sample : MSTB25#2、MSTB25#3、2EHDR-05P#2、2EHDR-05P#3

Test setup : Refer to Fig. 2

Remark : Measure push-off force after “Low temperature storage test”.

Sample No.	Visual inspection
MSTB25#2	No damage.
MSTB25#3	No damage.
2EHDR-05P#2	No damage.
2EHDR-05P#3	No damage.
